## **PRE-DEMOLITION ASBESTOS INSPECTION AND SAMPLING REPORT**

800 Meadow Pass Road  
Walnut, Ca.

**Project Number:** A/9400  
**Inspection Date:** August 13, 2022

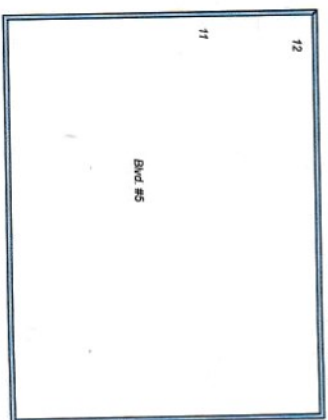
## **10.0 Appendix B- Site Map and Location of Samples**

800 Meadow Pass Road  
Asbestos samples  
(Positive samples in bold)
